*R. E. Cooper Building Specialties*  
Property Inspection Report

204 Sample Place, Syracuse, NY 13215  
Inspection prepared for: Mr. & Mrs. Sample Report  
Real Estate Agent: Donna Marando - Berkshire Hathaway

Date of Inspection: 2/4/2019 Time: 1:30 pm to 4:15 pm  
Age of Home: 1970s  
Weather: Clear, approx. 58 degrees

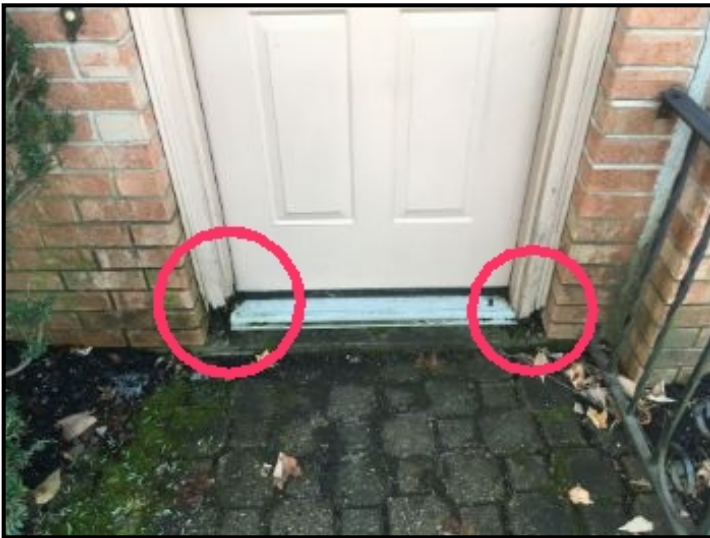
Roof water splashing two stories down onto soft to harder surfaces for years has caused decay and deterioration to many of the exterior doors. The work to repair these aging doors would not be worth the effort and many of these doors need replacing.

Breezeway entry door on front damaged due to roof water splash-needs replacing

- The rear entry doors in poor condition and needs to be replaced.
- The side entry doors in poor condition and needs to be replaced.
- The front garage entry doors in poor condition and needs to be replaced.

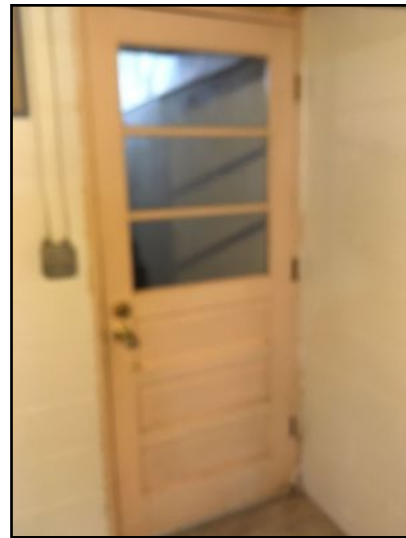
The basement entry door may not meet modern fire safety requirements as it is adjacent to the garage.

Many exterior doors have two way keys for a dead bolt. During an egress emergency these locks can pose an unsafe condition.

Basement door issues- would not meet modern fire rating and double keyed dead bolt unsafe

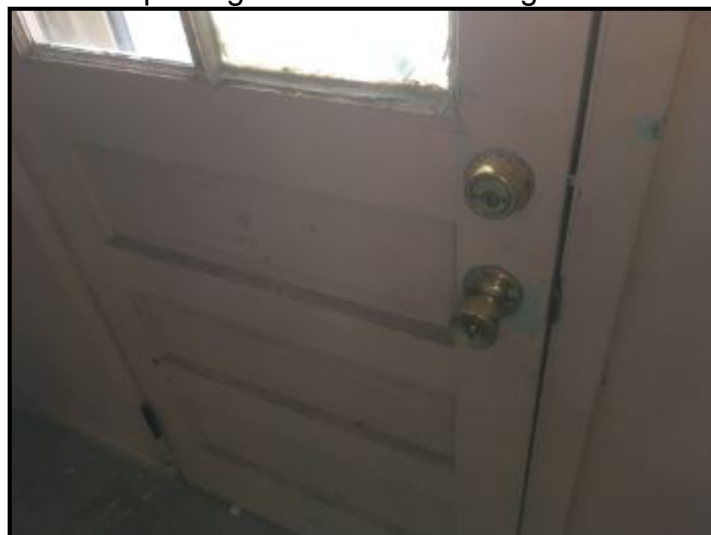
two way keyed dead bolts unsafe

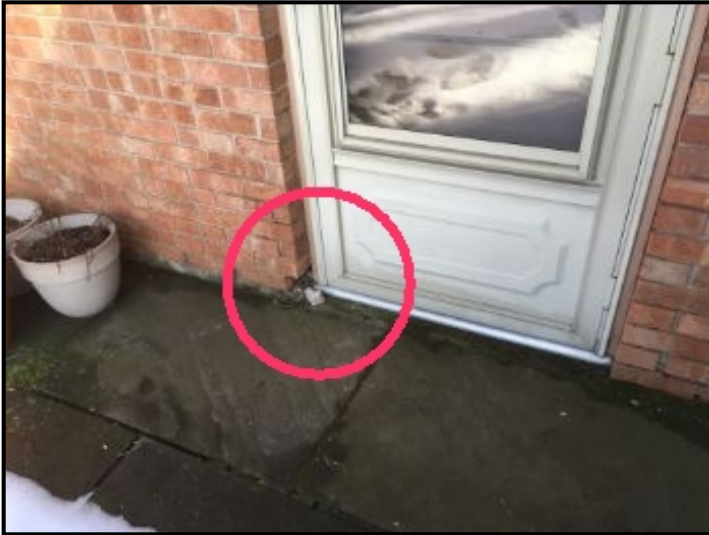
Minor brick deterioration around rear entry door due to roof water splash

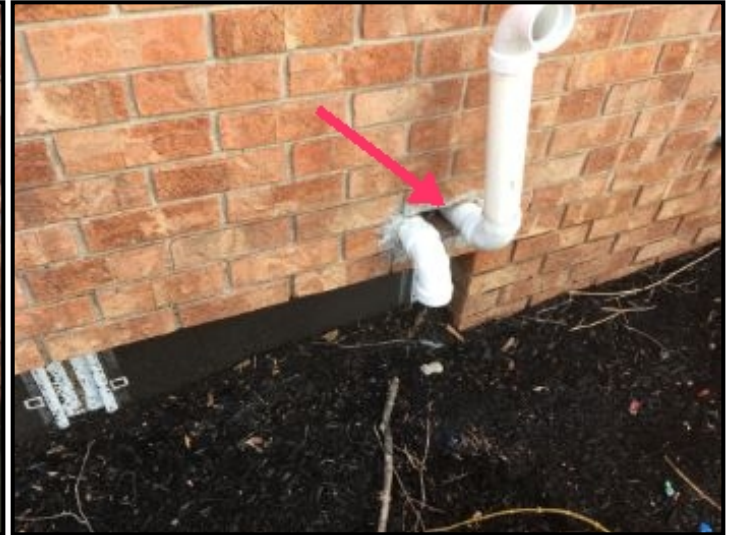
poor retrofit of furnace venting- brick needs sealing

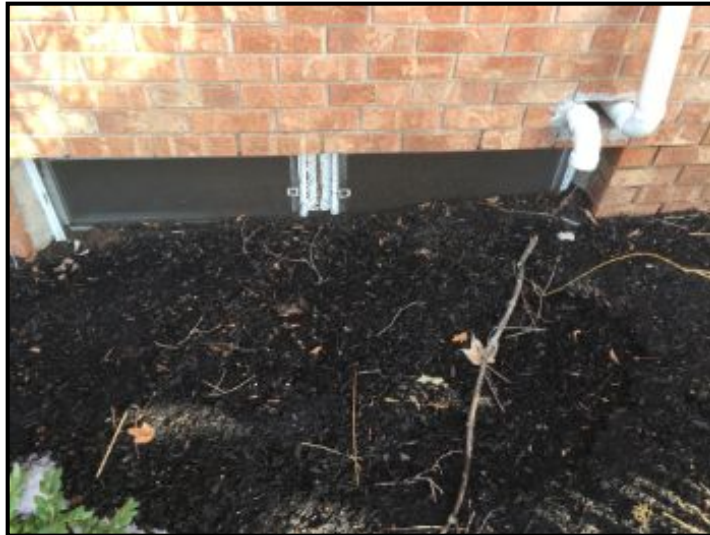
grades too high on rear basement windows, water splash also an issue causing undo deterioration

Grades at some of the basement windows are quite high with the combination of roof water will begin causing deterioration of the window units.

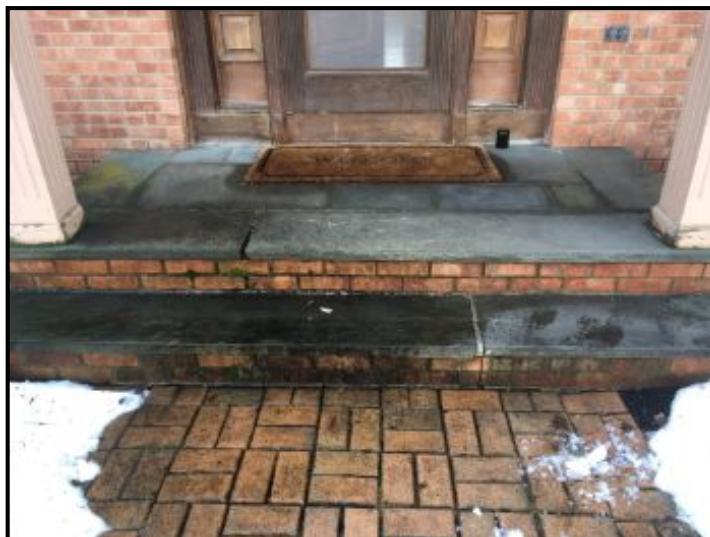
- The masonry on the front porch is in poorer condition and repointing and possibly resetting of materials on this porch are needed to bring the area into good cosmetic condition and seal the system from deteriorating weather.

Roof water splash causing deterioration of front entry stone and masonry - limestones need to be re-pointed to keep water out.

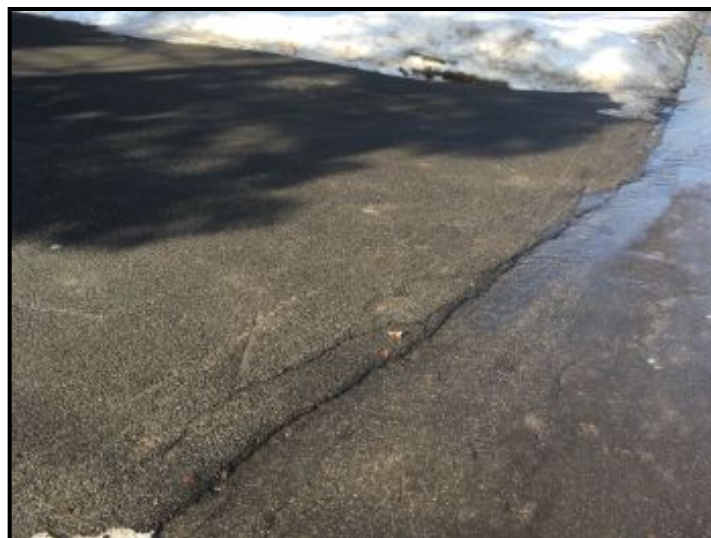
Driveway in good condition, will break up with time at road due to elevated finish and water flow.

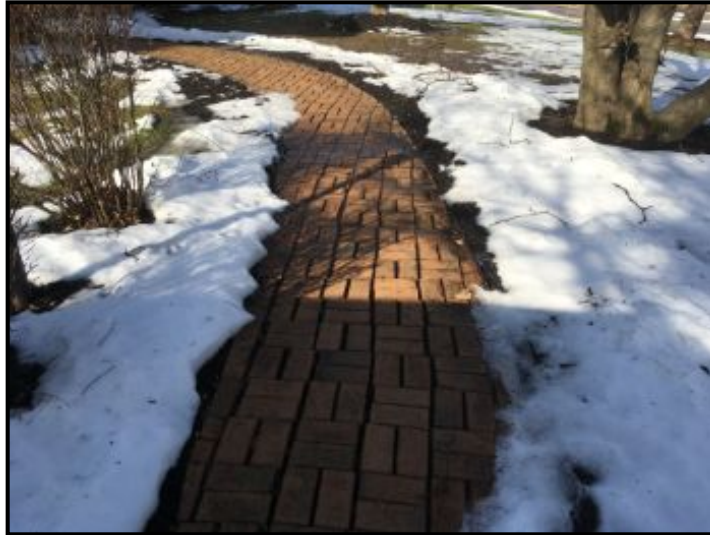
- The main entrysidewalk is in modest condition. Many of the pavers are humped or misaligned and should be reset.

Front paver sidewalk is in modest condition. Many bricks need re-setting to be flush and level.

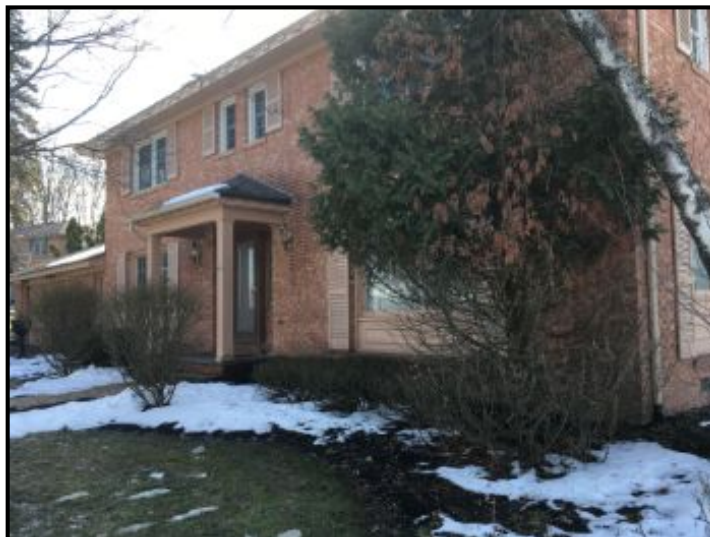
- Trees close to a building tend to cause vermin, insect, and decay damage. Trees should be kept trimmed back or cut down. The tree(s) on the of the house is too close and causing damage.

Trees need cutting back from structure

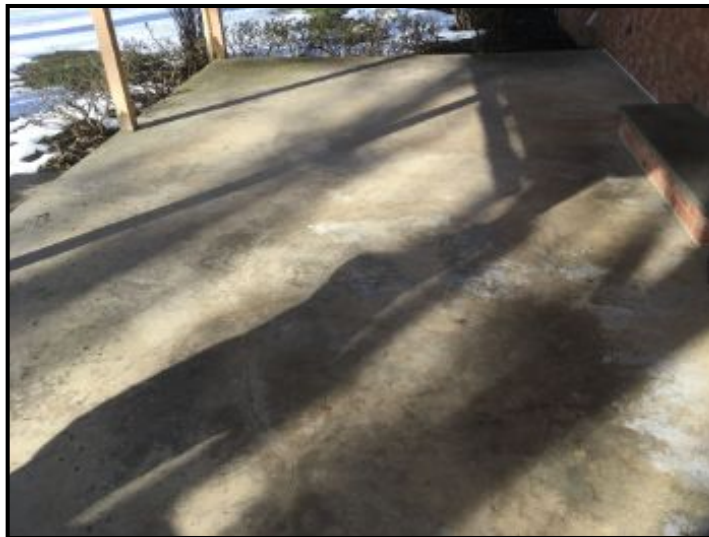
patio slab has spider cracking but found in reasonable condition

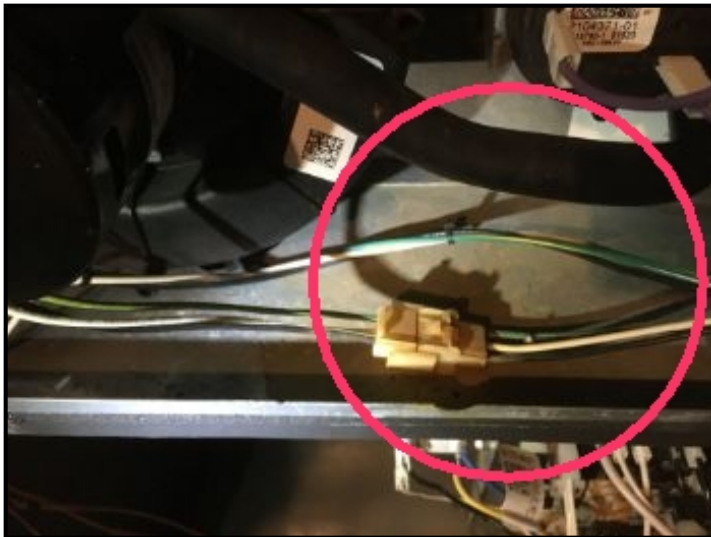
This condensate ponds on the base of the compartment. If substantial in volume the condensate then leaks down into the blower compartment where often the control - circuit board is located. If the condensate drips onto this board it will degrade affect the operation of the furnace.

Condensation is leaking in this furnace and it should be stopped.

Newer furnace showing signs of exhaust vent condensation leaks-needs sealing to prevent damage to circuit panel in lower compartment

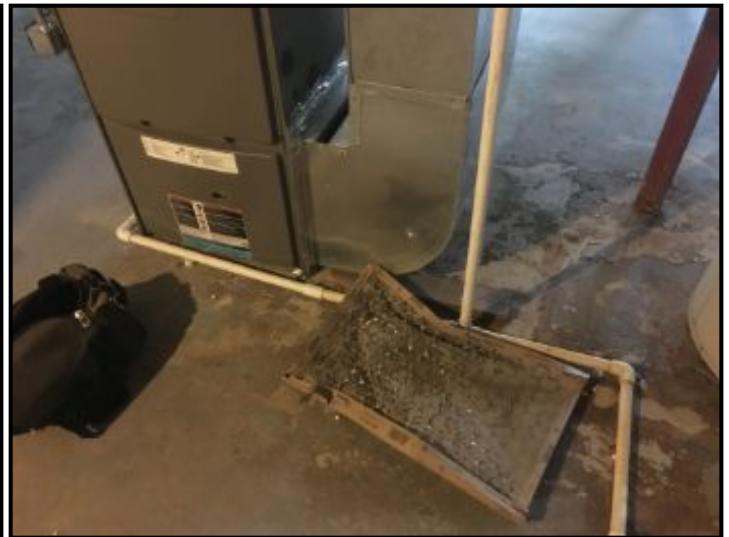
furnace presently working without filter-new filter needed.

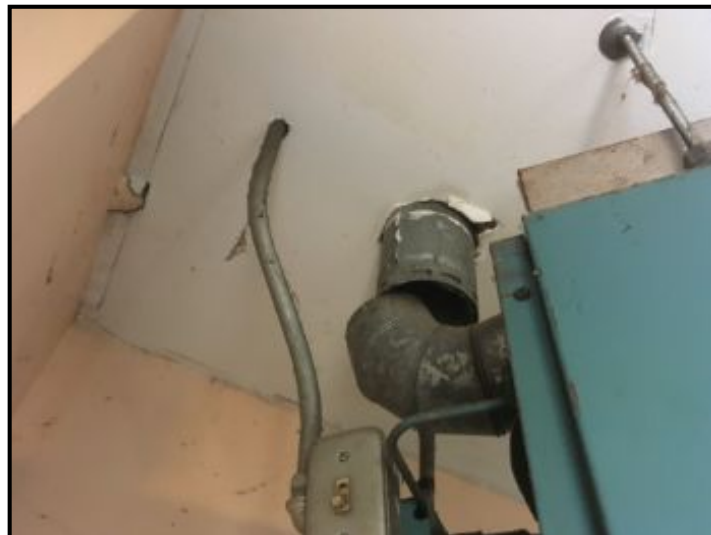
The exhaust vent for this unit was disconnected at the time of the inspection. This unit should not be operated until this condition is corrected and the unit is inspected and serviced by a qualified heating technician.

do not attempt to use garage heater prior to re-connecting exhaust vent-safety concern

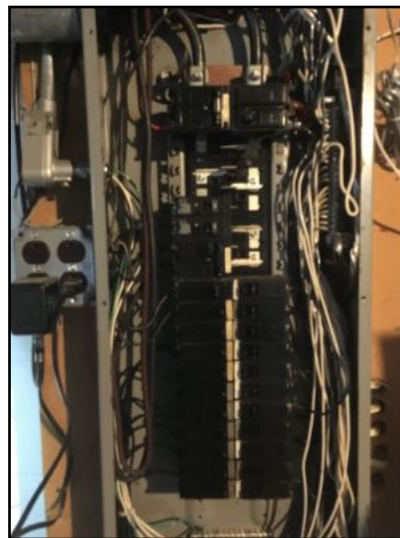
Under certain conditions this wiring has been known to contribute to house fires. This wiring was extensively and successfully used in many homes during the early to mid-70s.

Majority of branch circuits are aluminum

It is the recommendation of this home inspector that homes with this type of wiring are generally safe as long as remodeling is performed appropriately over the life of the home. With that said it is advisable for the client to have the wiring inspected by a qualified electrician. Then a discussion between the client and the electrician should occur to determine if and how much modification of the electrical equipment should occur.

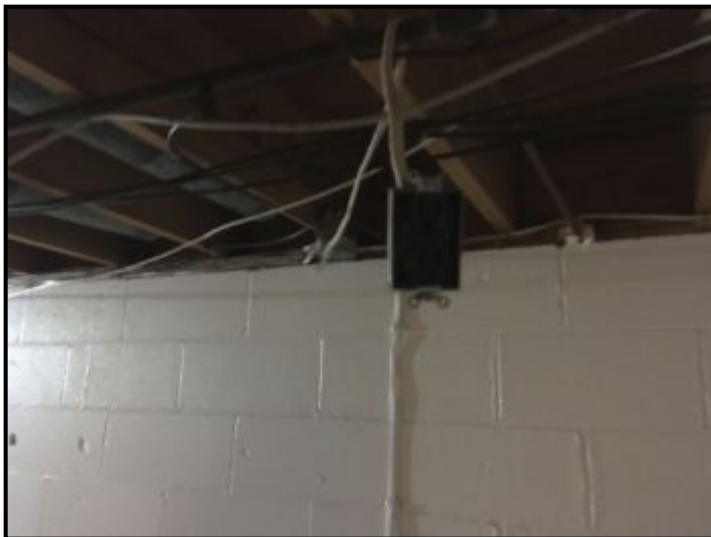
loose wiring and exposed outlets should be properly secured or eliminated

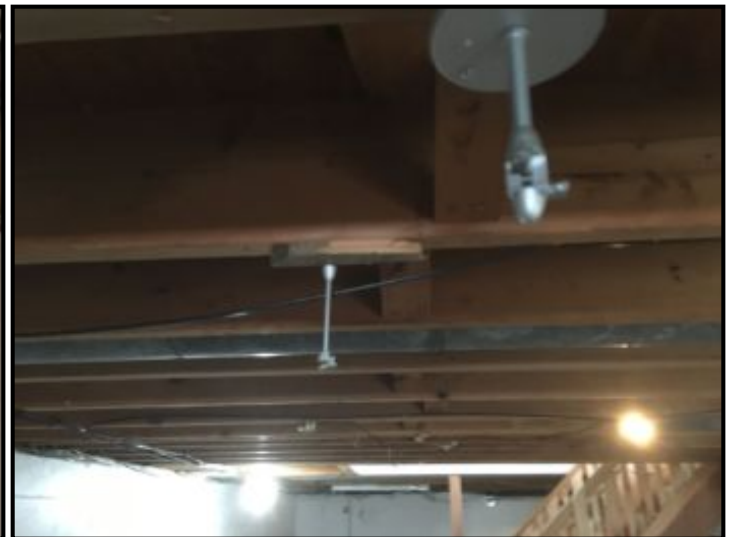
Misc. lighting in basement need terminating or replacing

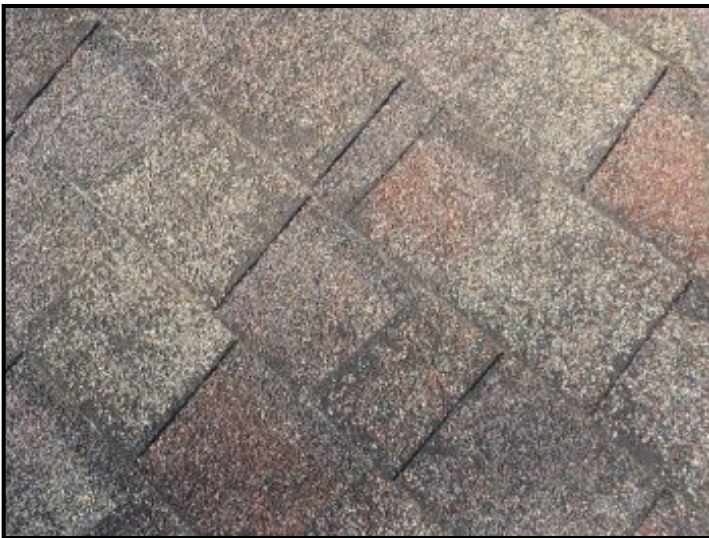
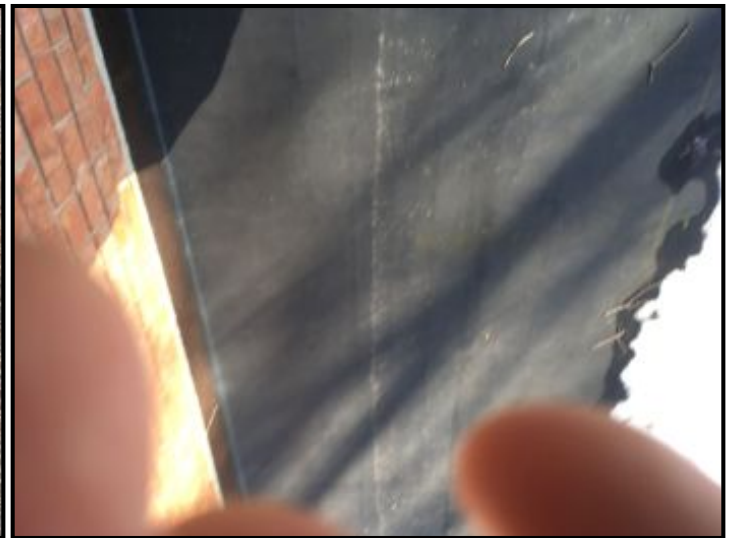
- The rolled roofing sections of roof were found in acceptable condition.
- The ceramic granules on a shingle protect the petroleum based materials below from deterioration from ultraviolet light from the sun. Often the shingle mix is such that these granules wear off prematurely. This is the case with the shingles on this roof. This condition may affect the life expectancy of the shingle and they may not get the full design life normally expected.

25 years architectural shingles may not may full life due to heavier loss of granular surface material. EPDM rubber roof on rear porch in good condition

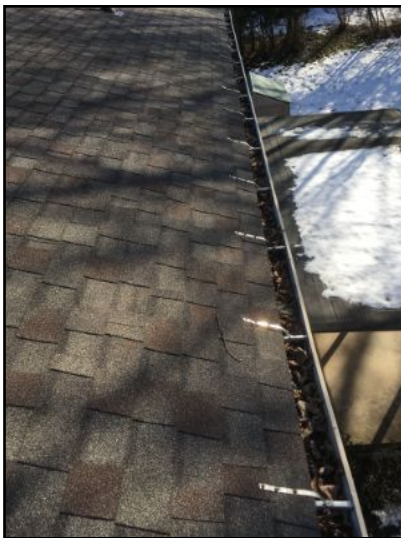
- Roof gutters are heavily plugged with leaves and debris. They cannot operate properly in this condition and often this condition causes issues that would otherwise not occur. The roof gutter need to be cleaned out and kept clean and in good working condition.

Plugged roof gutters

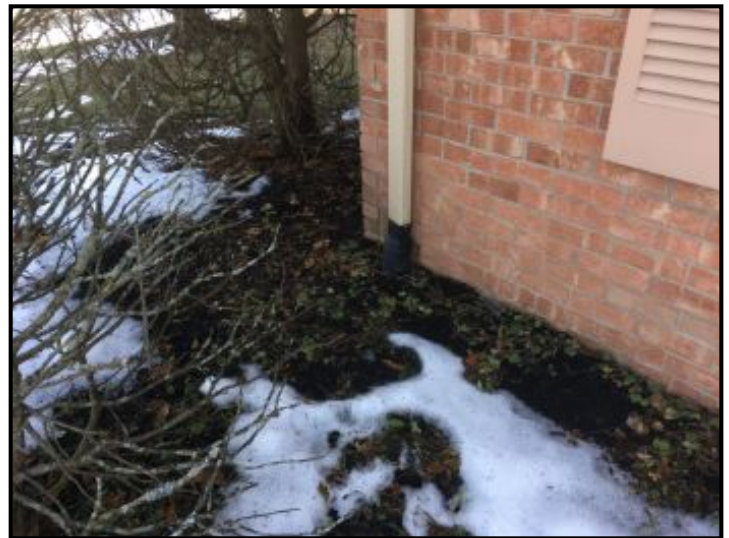
What is be said is that in their present condition it is hard to know whether these downspouts are properly routing water away from the foundation.

underground downspout leaders questionable-  
don't resurface-need to be corrected

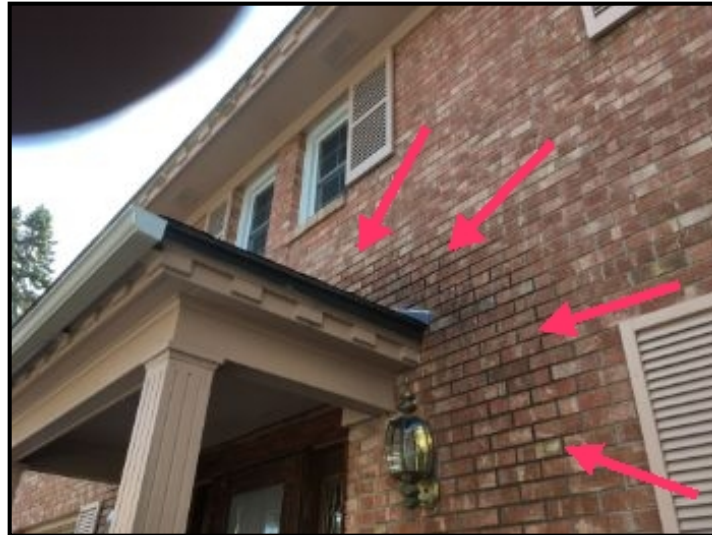
Lack of upper roof gutters causing brick deterioration

- There are roof gutters on the rear main section of this house. Additional gutters should installed to the upper sidefront main section area(s) of the house. Properly operating roof gutters with downspout extended well away from the house can do a lot to minimize dampness or water in the basement and to reduce deterioration of exterior components of the house.

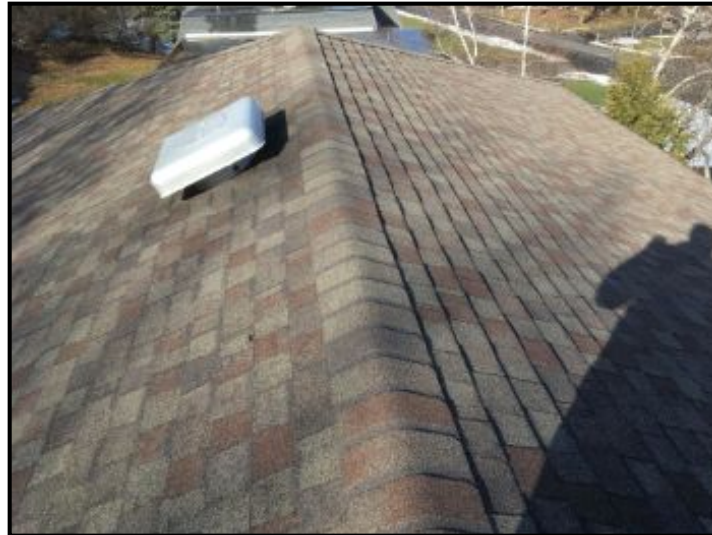
- Soffit vents only
- **Ventilation is not ideal in the attic of this house and addition ventilation is necessary to avoid further damage to structural components and to potentially minimize ice damming along the eaves in the winter.**

Roof ventilation is modest lacking ridge vent

- The installation of ridge vents is recommended for roof areas of this house where missing. Ridge vents are the number one desired attic ventilation mechanism. This type of ventilation distributes air flow across the roof system versus other ventilation methods that localize air flow. Ridge vents work best when coupled with lower soffit venting but they are a better stand alone venting system than other methods. Adequate attic venting minimizes heat and moisture build up in the attic that can contribute to mold in the attic, excessive heat in living areas during the summer, and excessive ice damming in the winter.

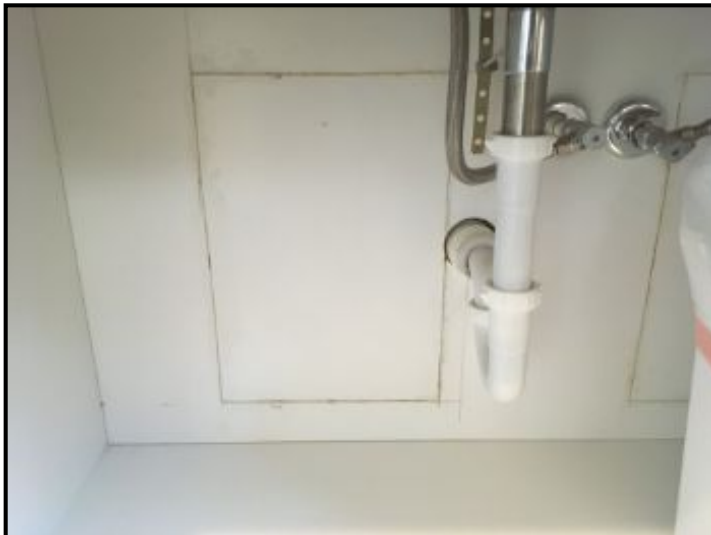
plumbing pipes on outside wall-questionable-possible repairs previously

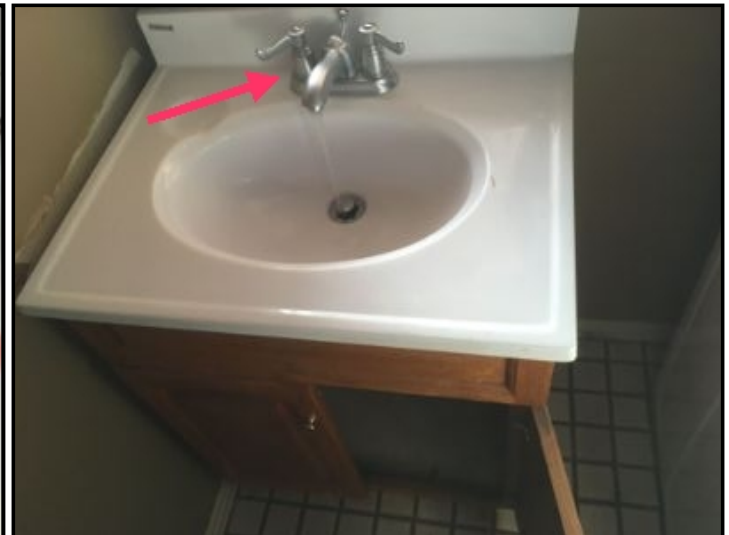
Aging fixtures in first floor 1/2 bath

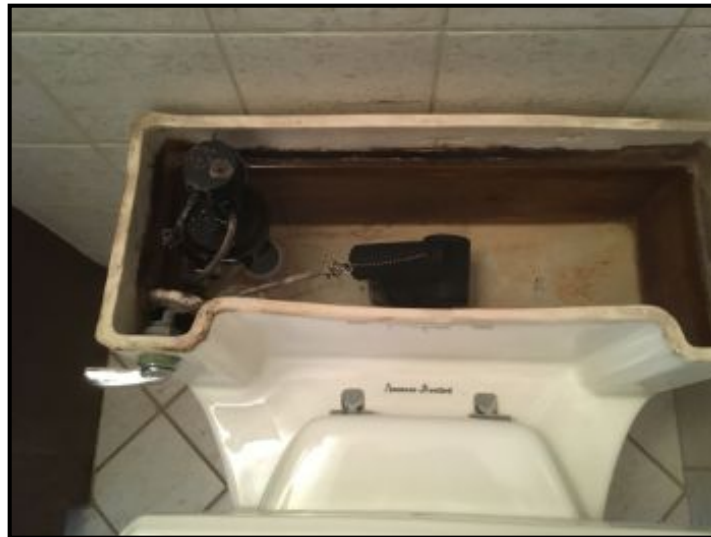
toilet in 1/2 bath marginal-toilet tank valve aging

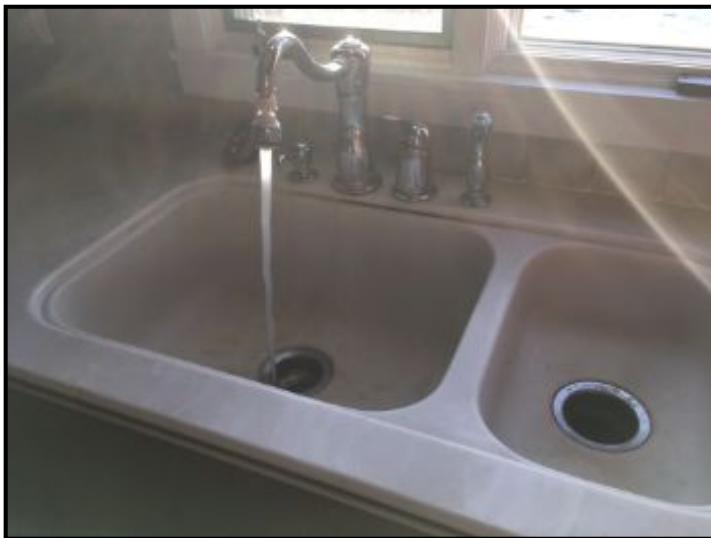
Aging sink and faucet in kitchen-faucet h

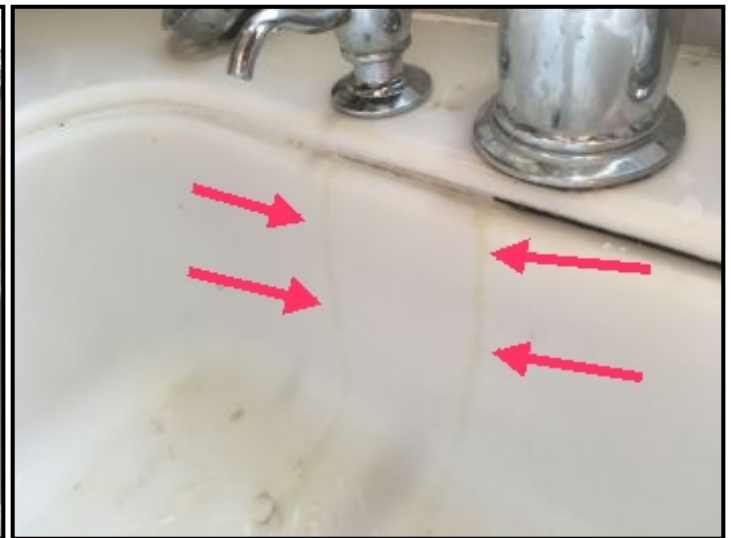
aging kitchen faucet leaking

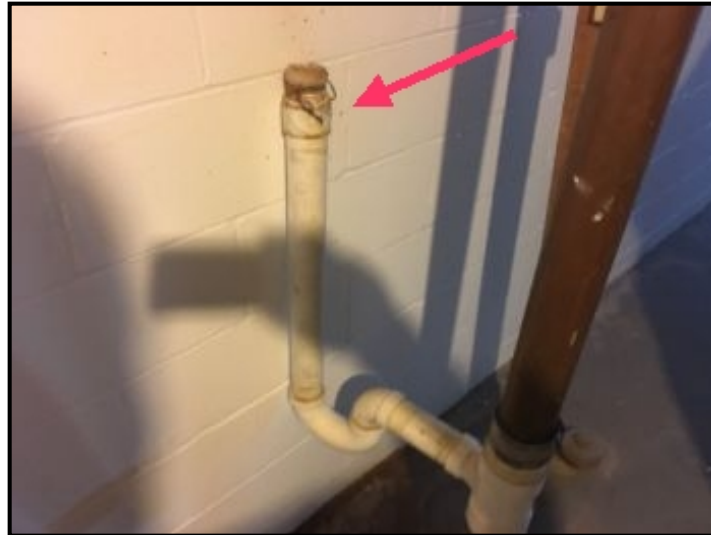
unused laundry drain on basement needs to be terminated

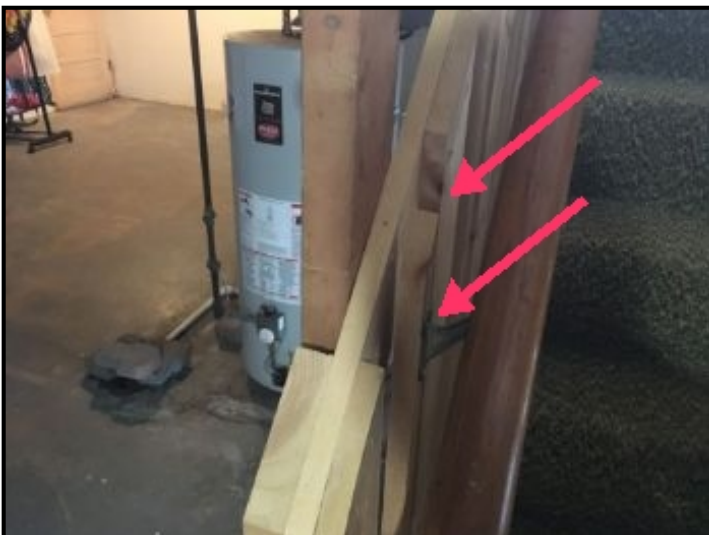
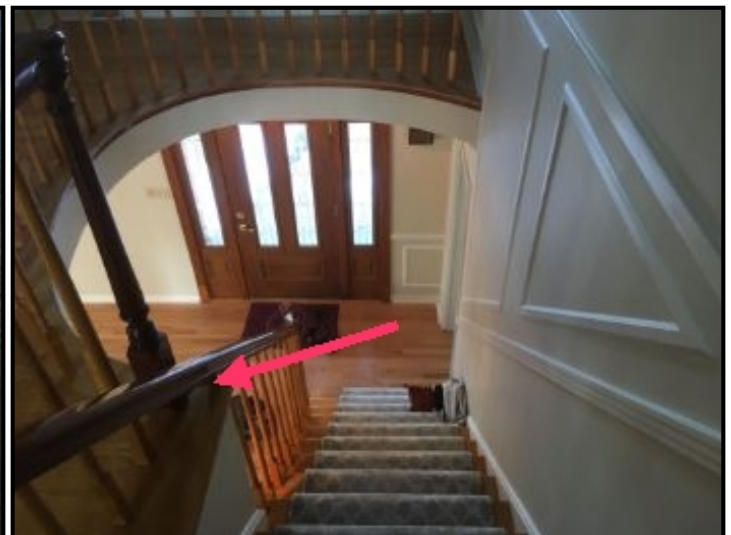
basement railing needs re-securing at lower end main stairs railing needs new bracket to be secure

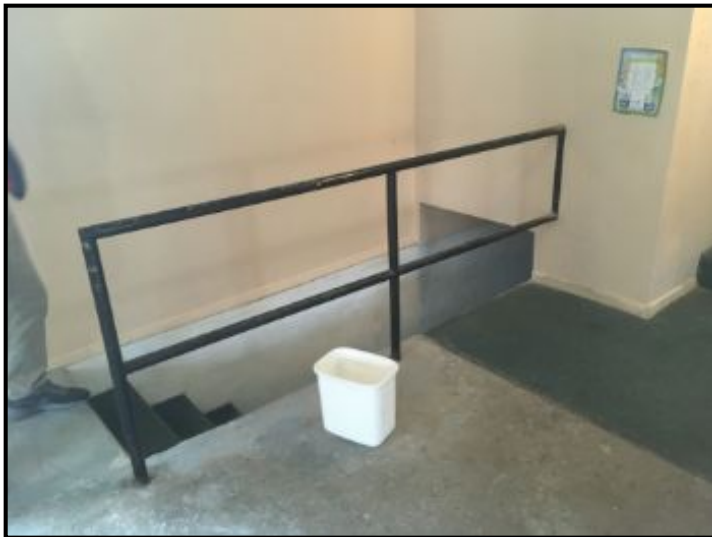
garage safety rail not safe due to wide spacing

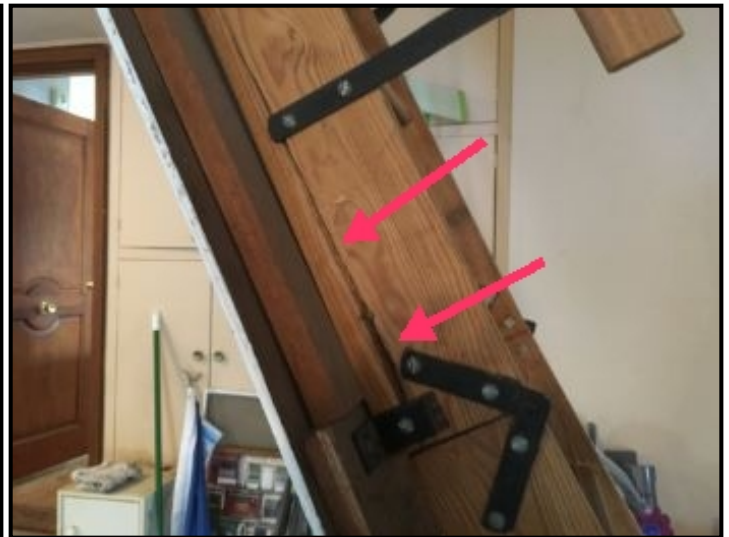
roof ladder damaged -needs repairs for safety

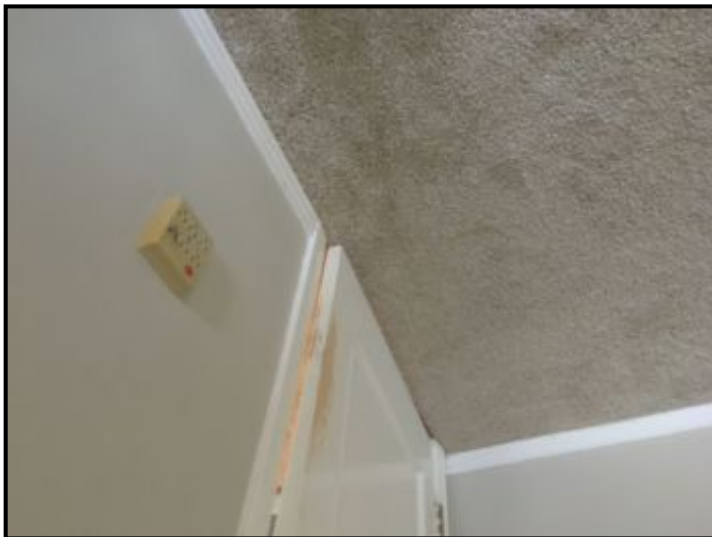
dog damage to master bedroom door

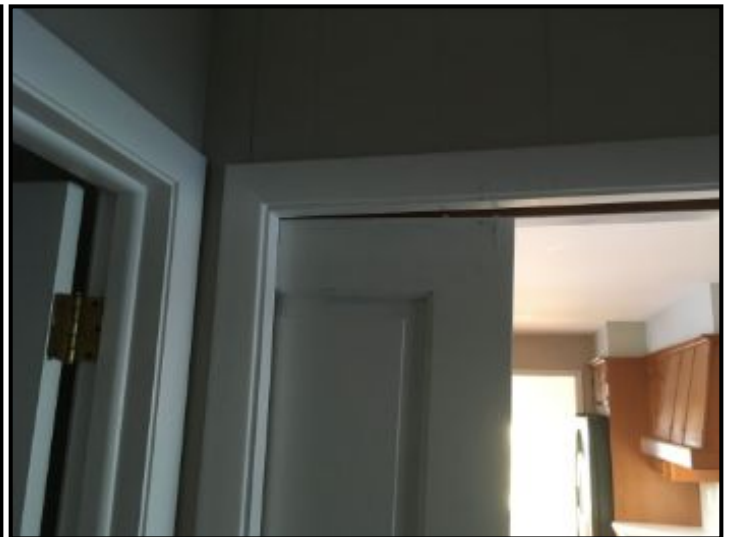
Pocket door not operational-between kitchen & family area

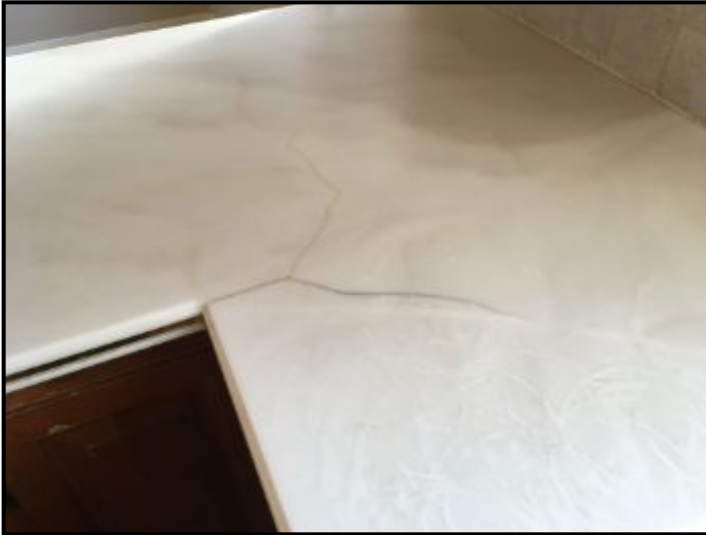
kitchen solid surface counter damaged

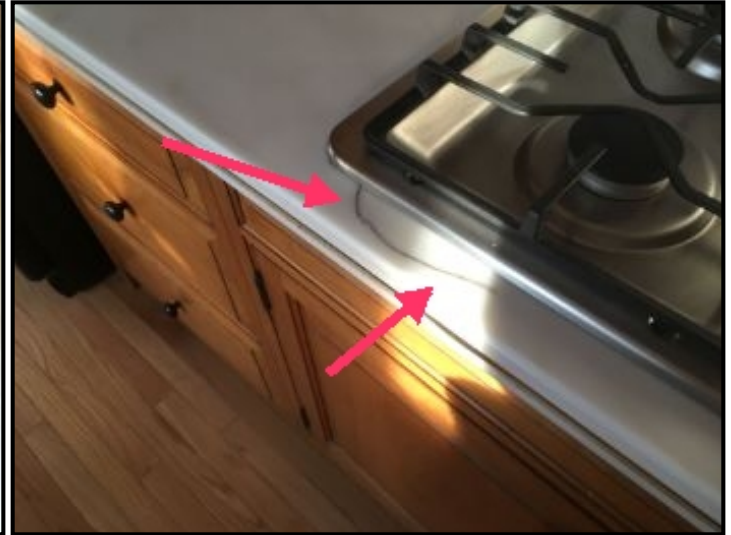
Kitchen counter solid surface damaged at stove

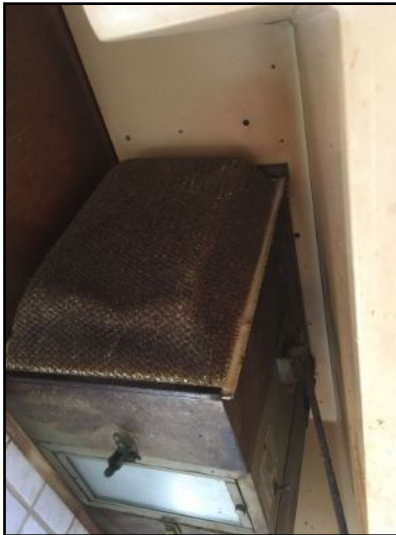
Filter and hood system over stove very marginal

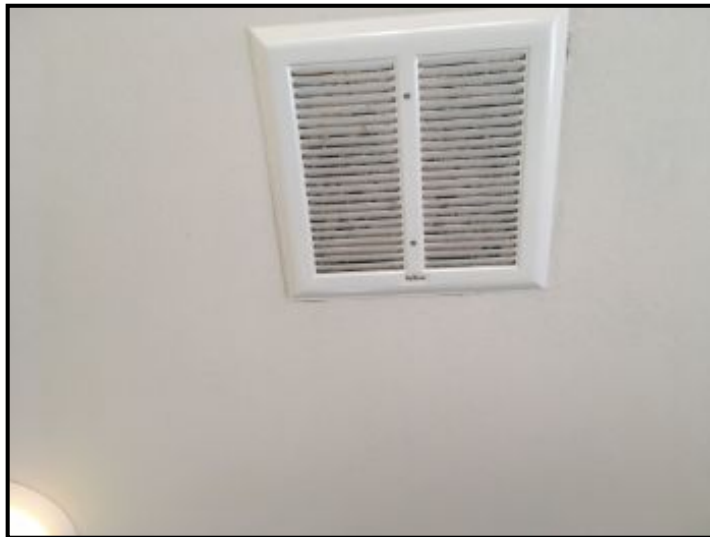
- The bathroom fan covers should be removed and cleaned.
- The discharge for the all bathroom was not identified- it needs to vent to the exterior of the house to avoid moisture damage to wood components.

bath fans need cleaning

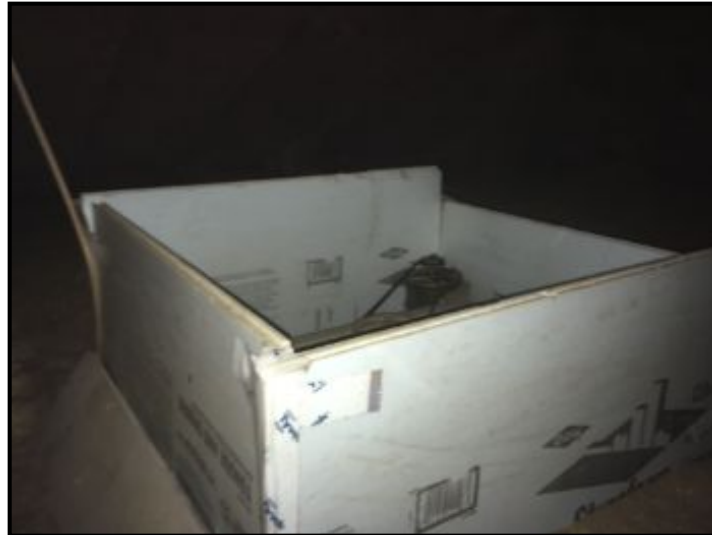
whole house fan needs sealing in winter to avoid excessive heat loss

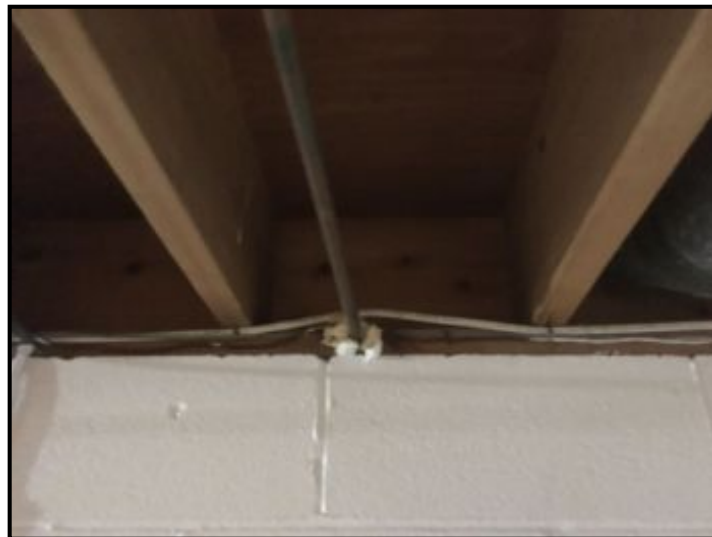
- No major concerns were identified with the floor structure.
- Ideally the perimeter of the first floor should be insulated and sealed for optimum energy efficiency. Modern homes are often foam sealed in this area (the band joist) which is the best seal. Otherwise wherever air can be felt moving caulk seal and batt fiberglass insulation should be installed wherever it presently does not exist to the band joist area(s).

Band joist of floor system needs sealed and insulated

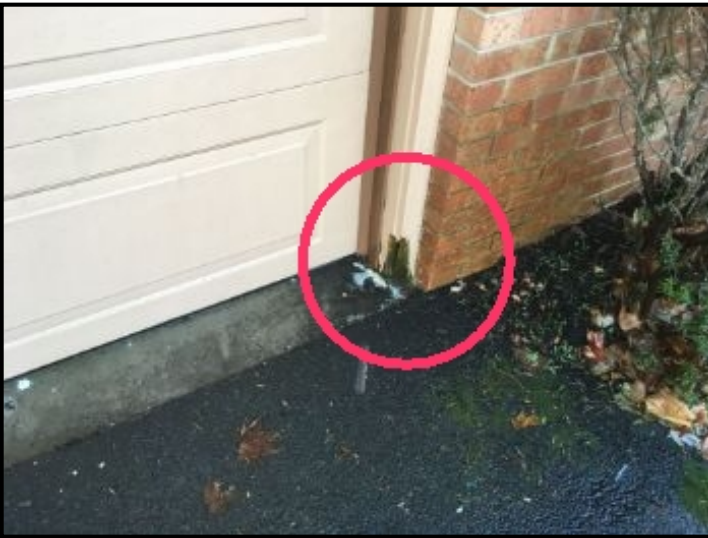
Overhead garage door jamb and trim heavily decayed at base due to roof water splash

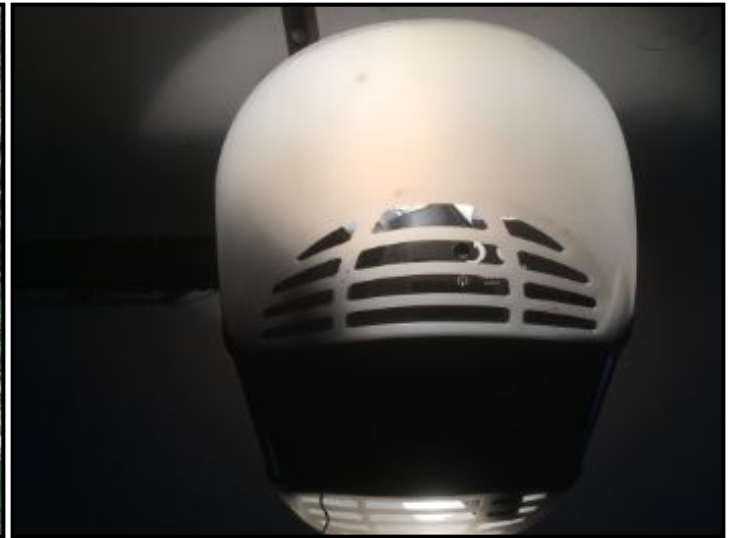
garage door operator needs to have downward pressure reduced for safety

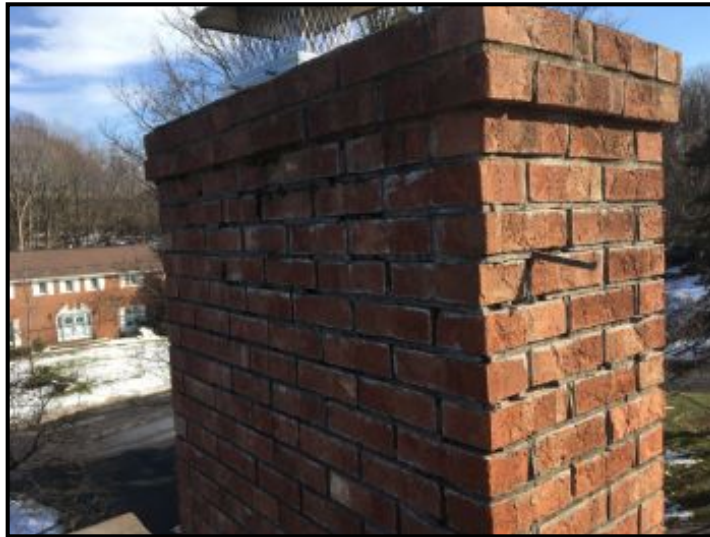
- The crown area of the chimney is showing mortar deterioration and other damage to the masonry that needs attention to avoid further deterioration. This area of the chimney needs moderate repairs by a professional mason.

Costs for this repair are difficult to assess as the work is mostly all labor. It would not be uncommon for this type of repair to cost \$ 2,000 to \$ 3,000.

Chimney crown needs moderate amount of work-repointing and water sealing

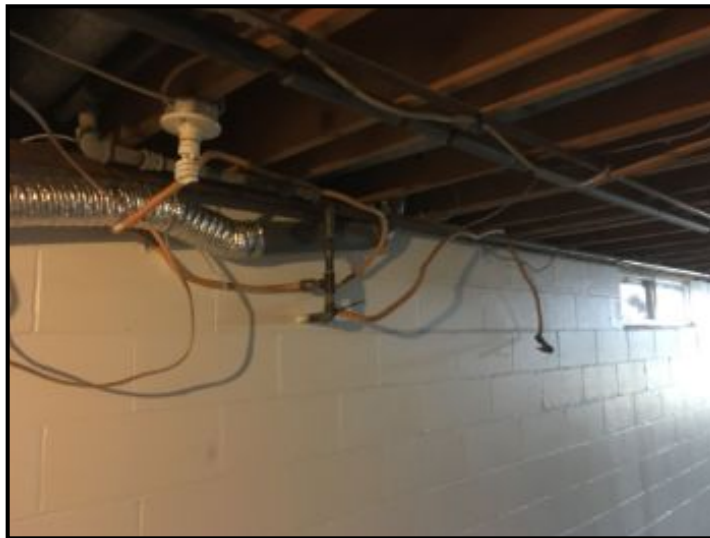
Flexible gas line needs to be terminated
